MISCELLANEOUS PAPER S-71-29

EVALUATION OF HARVEY ALUMINUM 1- BY 12-FT EXTRUDED LIGHT-DUTY LANDING MAT WITH OVERLAP/UNDERLAP END CONNECTORS

December 1971

Conducted by U. S. Army Engineer Waterways Experiment Station, Vicksburg, Mississippi

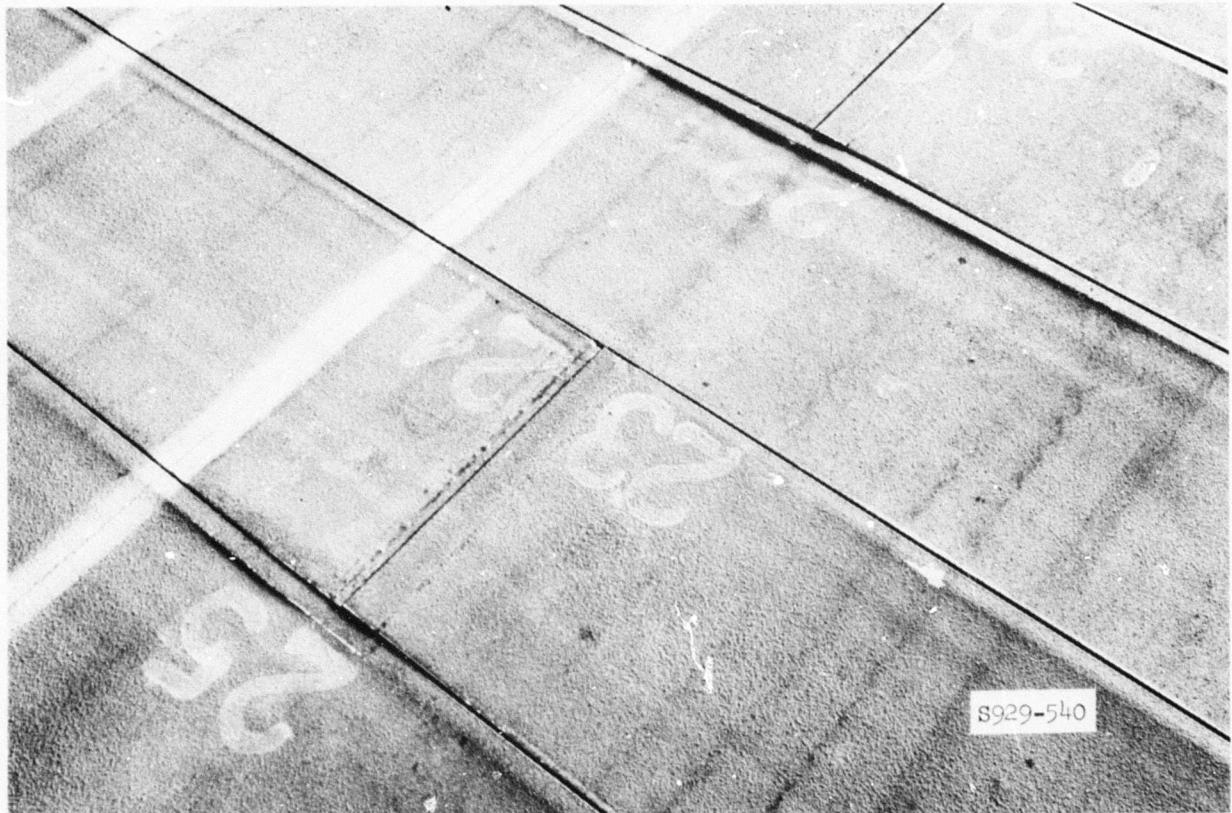
Photograph 7. Splits and depressions in the top skins of panels 22 and 25
after 340 coverages

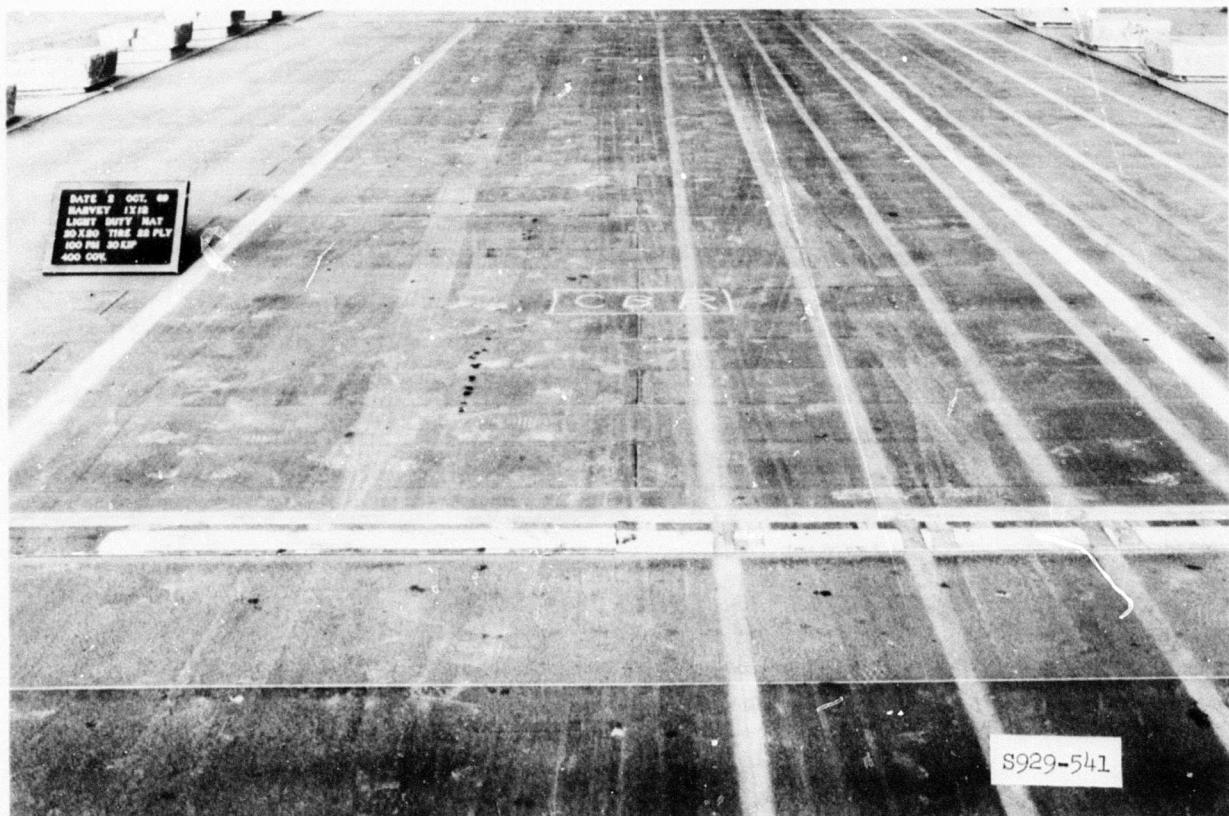
26. Traffic was continued in a normal pattern to 400 coverages (photograph 8). After 400 coverages, 11 panels contained breaks in the top skin adjacent to the female rail. These breaks were 4-1/2 to 29 in. long. Panels 22, 25, 43, 46, 52, and 55 had breaks in the top skins, which indicated that internal rib failures had occurred, and these panels were considered failed at 400 coverages. Photographs 9 and 10 show closeup views of the breaks in the top skins adjacent to the female connectors of panels 22 and 25 and 52 and 55, respectively, after 400 coverages. These breaks were tire hazards. In addition to the six failed panels, panels 28, 31, 34, and 37 had splits but were not considered failed at 400 coverages.

Photograph 8. Test section after 400 coverages

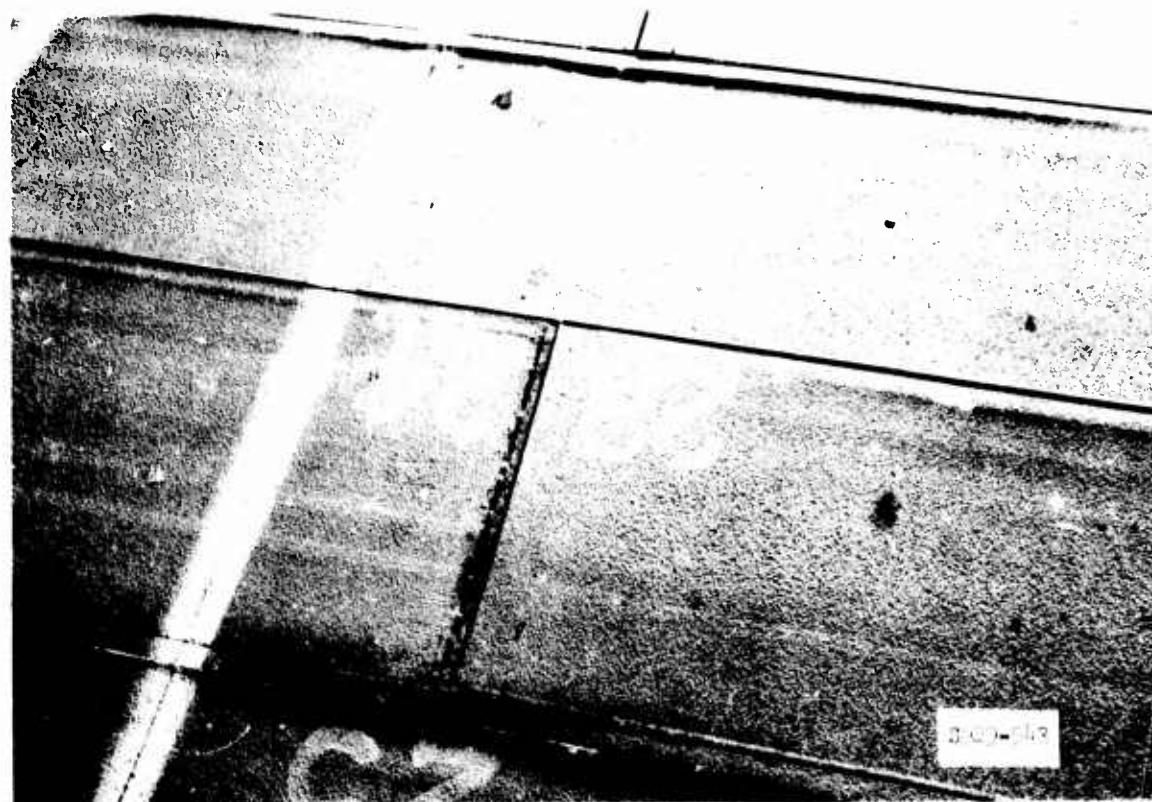
Photograph 9. Breaks in the top skins adjacent to the female connectors of panels 22 and 25 after 400 coverages

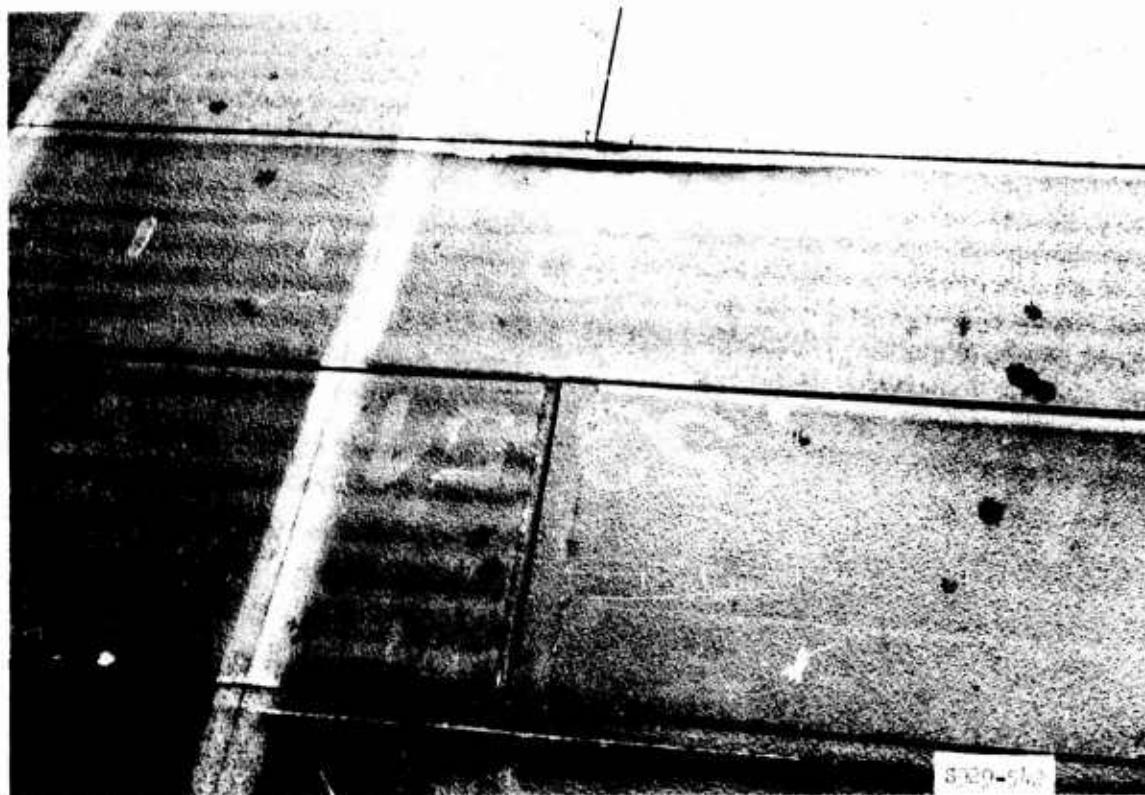
Photograph 10. Breaks in the top skins adjacent to the female connectors of panels 52 and 55 after 400 coverages

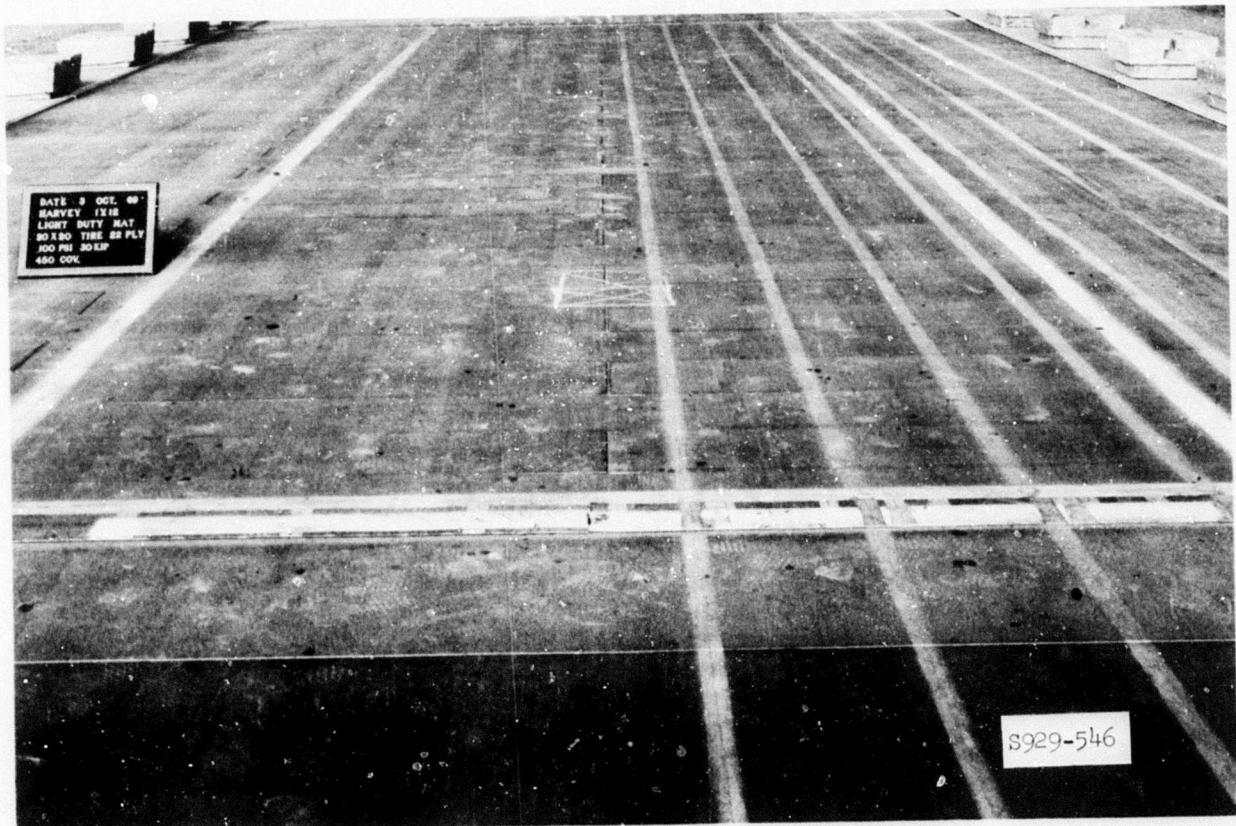
28. When traffic was continued after the mats were inspected after 400 coverages, popping and crackling noises could be heard as the load wheel moved over the section from run 19 (see plate 1) north. These noises indicated internal rib failures. Traffic was stopped at 450 coverages because six additional panels had splits in the top skins that were tire hazards (photograph 11). Since more than 10 percent of the panels in the 100 percent traffic area had failed, the test section was considered failed after 450 coverages. Photograph 12 shows the test section after 450 coverages.

Photograph 12. Test section after 450 coverages

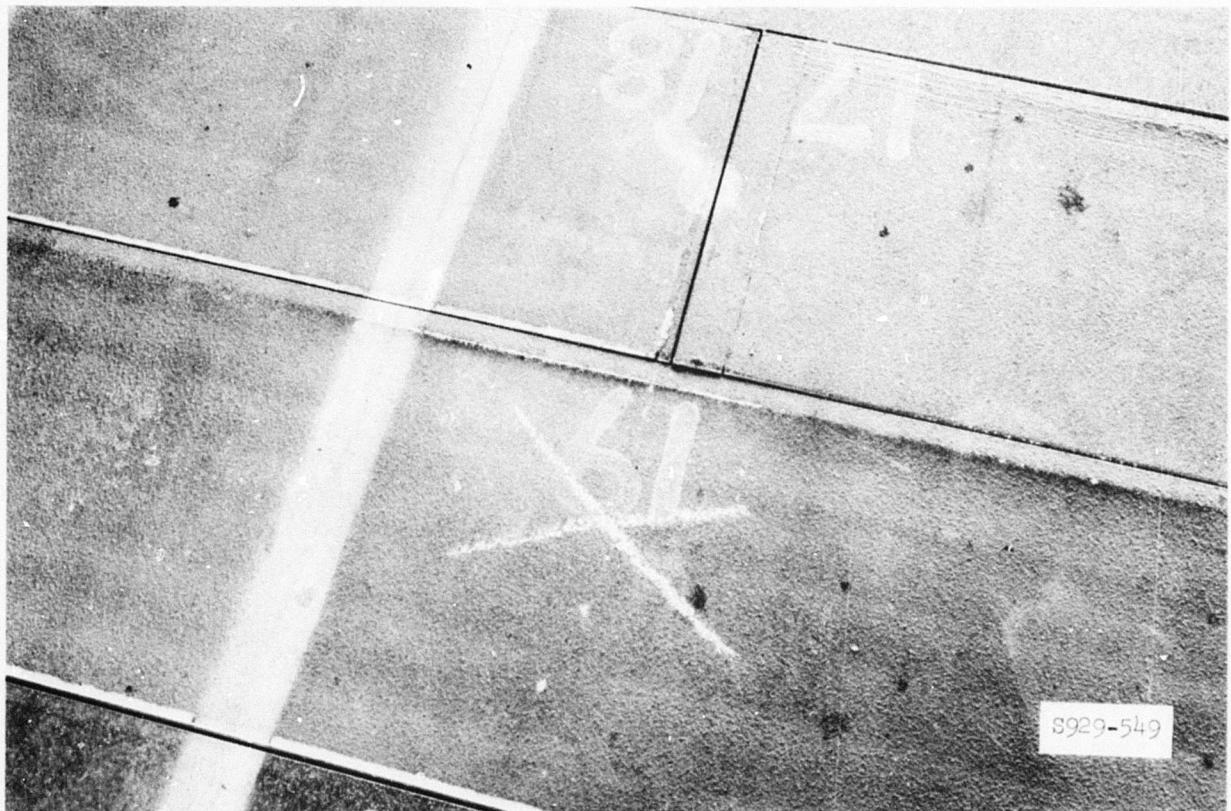
evidence of internal rib failure were then sawed to expose a cross section of the mat structure. Photographs 13 and 14, respectively, show a break in the top skin of panel 19 adjacent to the female connector and a cross-section view of failures in panel 19. Photograph 15 shows breaks in top skins at the female edges of panels 25 and 28. Photograph 16 shows a bow of approximately 3 in. in a 12-ft-long panel. Photographs 17 and 18, respectively, show a break in the top skin of panel 37 along the female edge and breaks and damage in the bottom skin of panel 37. Photographs 19 and 20, respectively, show a break in the top skin of panel 43 and breaks in and indentation of the bottom skin in panel 43. A cross-section view of internal rib failures in panel 43 is shown in photograph 21. Photograph 22 is a cross-section view of panel 45 showing rib failure. A cross-section view of panel 49 showing rib failures is shown in photograph 23.

Photograph 13. Break in top skin of panel 19 adjacent to female connector after 450 coverages

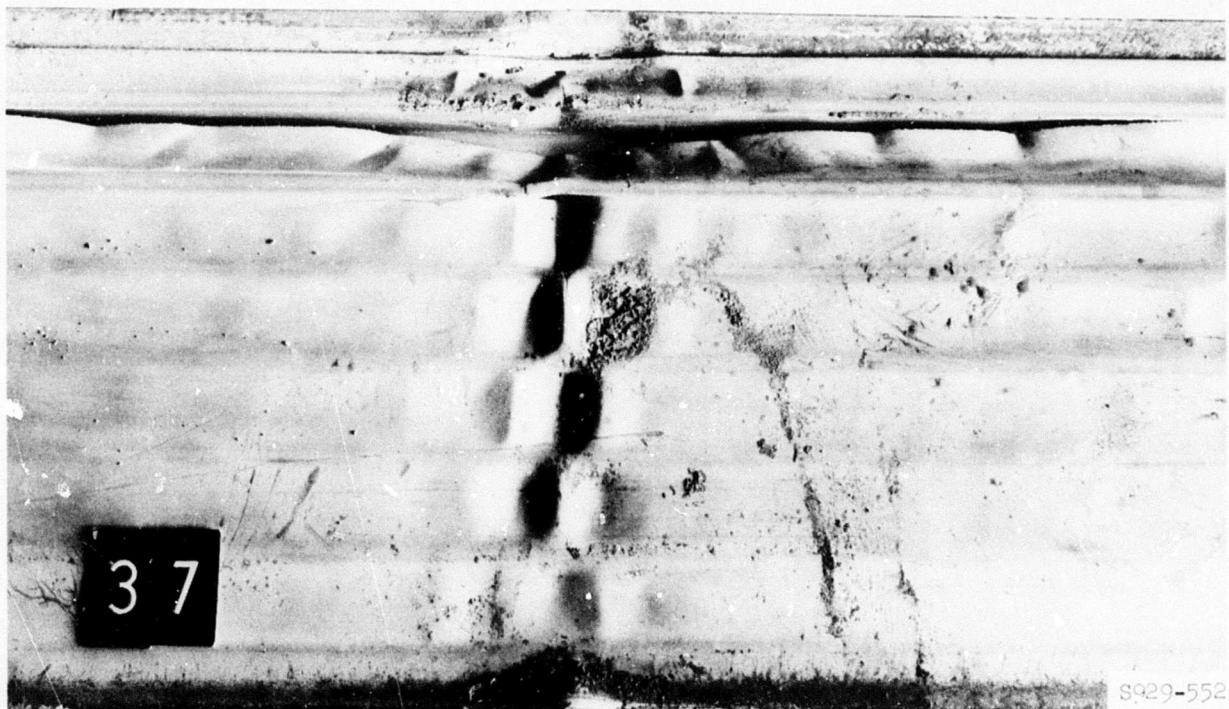
Photograph 18. Failures in bottom skin of panel 37 after 450 coverages

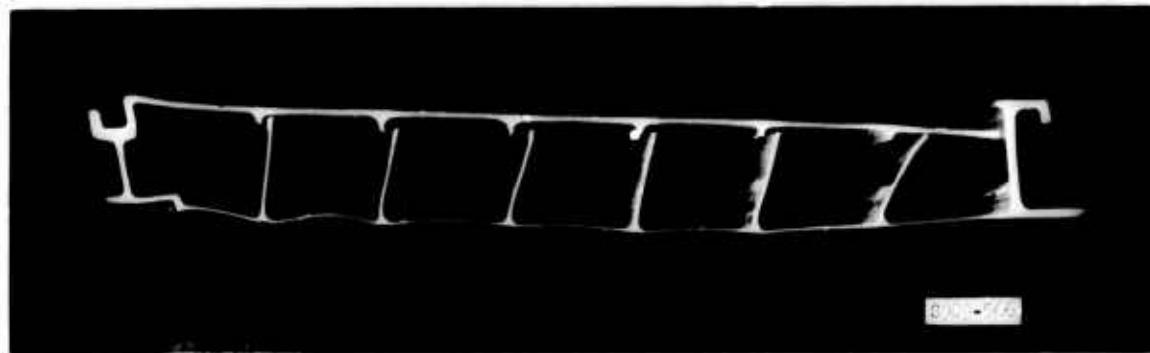
34. All of the mat panel failures in the 100 percent traffic area were due to top skin breaks adjacent to the connectors, internal rib breaks, and breaks and deformation of the bottom skin. This indicates that (a) additional strength is needed in all of these areas to improve the performance of the mat, and (b) no one area of the extrusion appeared to be stronger than any other area.

Photograph 21. Cross-section view of internal rib failures in panel 43
after 450 coverages

43. Based on the results obtained in this investigation, it is recommended that the cross-section configuration of the Harvey light-duty mat be changed to determine if additional strength can be obtained in the radii and internal ribs.
